Manhole Inspection Summary

Manhole # S57I__001MH

Insp Date: **7/1/08 3:15 PM**

Location Address: **4020 s haven st**

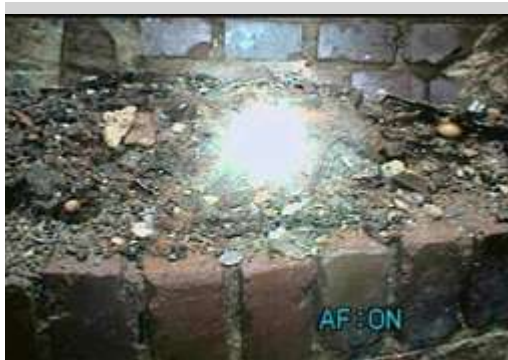
Defect 3

Condition: ☐ Sound ☐ Cracked ☐ Root Intrusion ☐ Deteriorated ☐ Leaks ☒ **Debris**

bench debris

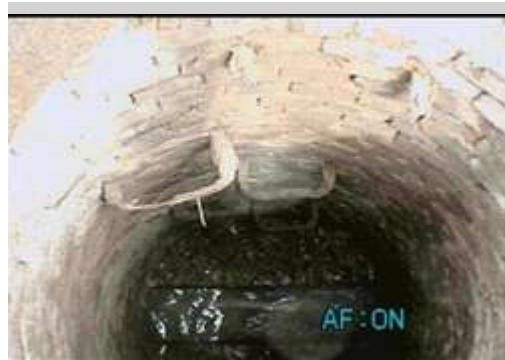
Defect 2

Steps Count: **6** Missing: **2** ☒ **Corroded**

corroded steps

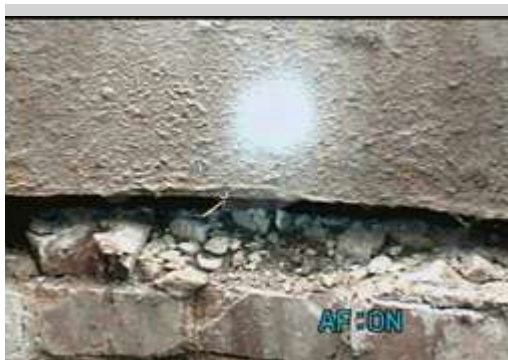
Defect 1

Condition: ☐ Sound ☒ **Cracked** ☐ Root Intrusion ☒ **Loose Brick** ☒ **Deteriorated**

chimney loose bricks, cracked and
deteriorated
, frame adj

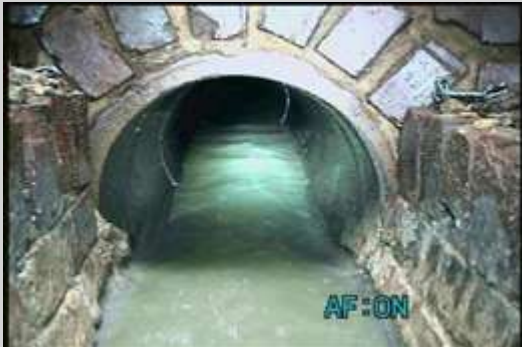
12 O'Clock Outflow

12 in. Circular Gravity Sewer
Pipe Out @ 12 O'Clock

Pipe Material: **Clay** ☐ Pipe Lined

Invert Depth: **9.92** (ft.) Flow Characteristics: **Slow**

Deposits: ☒ None ☐ Mud ☐ Sludge ☐ Debris ☐ Grease

Infiltration: **None** Pipe Seal Cond: **Unknown**

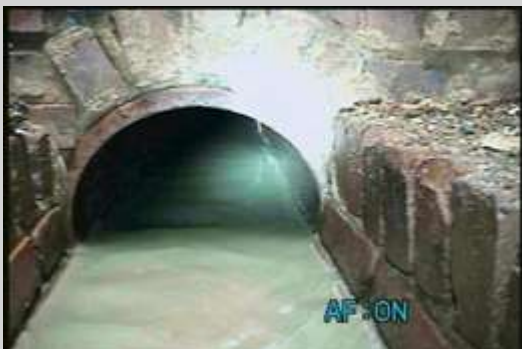
6 O'Clock Inflow

12 in. Circular Gravity Sewer
Pipe In @ 6 O'Clock

Pipe Material: **Clay** ☐ Pipe Lined

Invert Depth: **9.91** (ft.) Flow Characteristics: **Slow**

Deposits: ☒ None ☐ Mud ☐ Sludge ☐ Debris ☐ Grease

Infiltration: **None** Pipe Seal Cond: **Unknown**
